Sewer Scope Inspection Report

Property Address:
9876 Picket Fence Rd
CO

Inspection Date:
5/5/2015

1. Sewer Scope Inspection

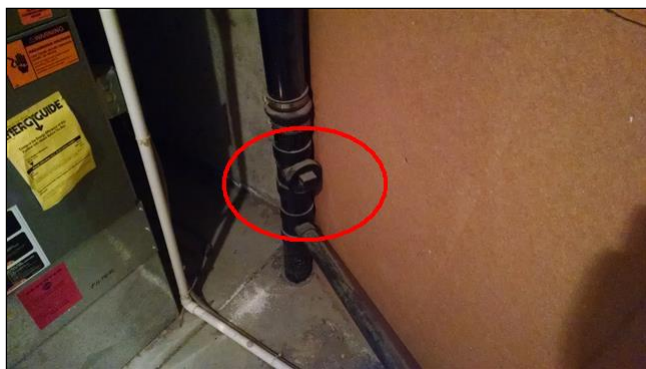
1.0 Item 1(Picture)

A clean out was present in the basement. The camera inspection was performed through this location.

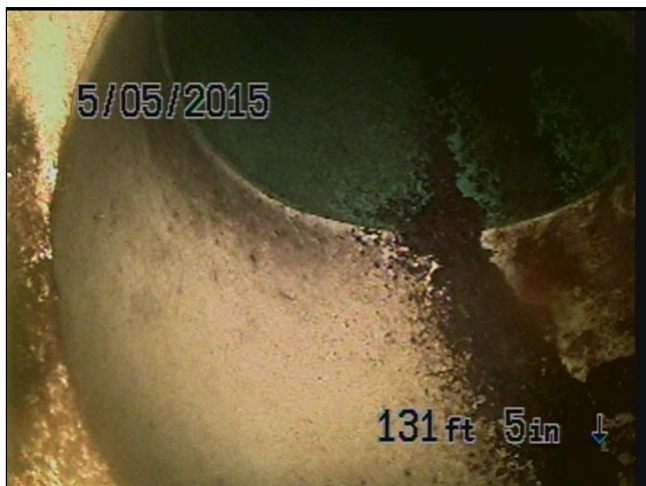
1.1 Item 1(Picture)

The overall length of the sewer line from the entry point to the sewer main is approximately 130 feet.

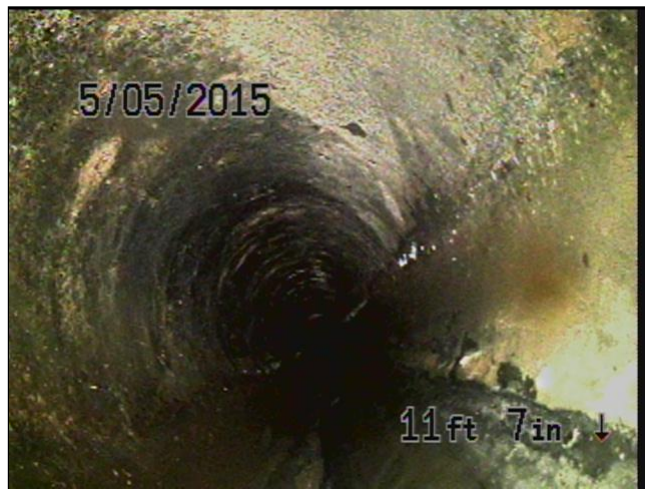
1.2 Item 1(Picture)

The sewer line was in good condition when the camera scope was performed. No areas of concern were noted at this time. Periodic inspection of the line is recommended, to ensure the line remains in good condition, with no root intrusion or other concerns developing. No action is needed at this time.
