Scott Home Inspection, LLC

Inspection Picture of the Month:

Death of a Water Heater... A common item discovered during a home inspection is rusting and leaking of water heaters. Most homeowners don't spend a lot of time inspecting their water heater. It's more fun to watch the grass grow. The home inspector is likely the first person to take a close look at this unit in a long time...

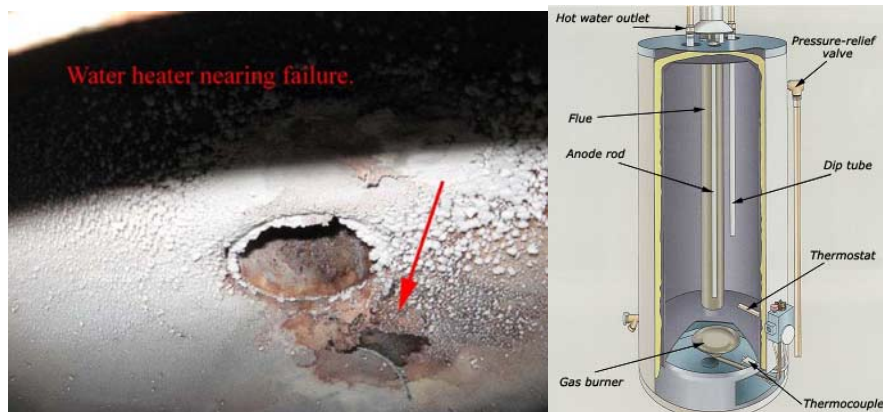
The most common mode of failure on gas-fired water heaters is for rusting to occur in the gas burner fire-pot area, where the vent pipe runs up through the unit, as shown below.

The average life of a gas-fired water heater is 12-15 years. Units in this condition need to be replaced, to prevent damage to the surrounding areas of the home.
