# Inspection Connection

*e-Newsletter from Scott Home Inspection*

FEBRUARY 1, 2007

## Inspection Picture of the Month:

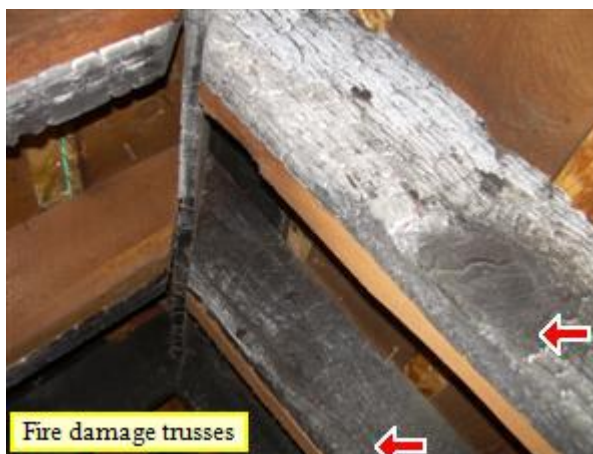
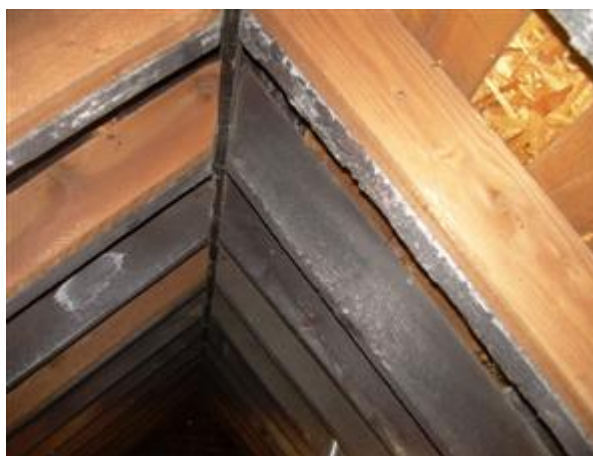
**Secrets in the Attic...** The inspection of the attic is usually routine, with a check of insulation levels, proper ventilation, signs of leaks, etc. But, every once in a while, you come across a surprise.

**The roof trusses showed signs of extensive fire damage.** While new framing members were added along side the burnt ones, there was a question of structural integrity.

It was advised that a Structural-Engineer come in and take a close look at the method of repair, and determine the adequacy of the method used. This could end up being a very expensive repair. Thankfully their home inspector discovered the issue!
