Scott Home Inspection, LLC

## Inspection Picture of the Month:

**Ceiling Cracks aren't always cosmetic items:** On older homes, you often see small hairline cracks in the drywall or plaster. Many times it is from minor settlement, and is not a significant item.

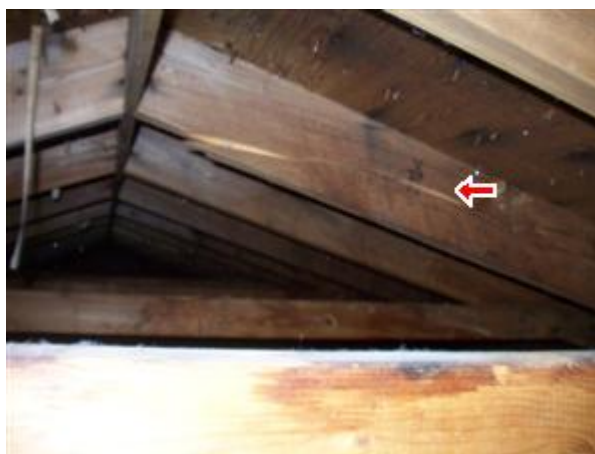
Attic's are inspected for not only insulation levels, leaks, and ventilation concerns, but when we see this type of ceiling cracking, it is important to inspect the rafter and joist system.

In this case, we had a split roof joist directly over top of the cracks. The homeowner had patched the cracks, but the cracks had returned, likely due to the snow loads and seasonal changes causing deflection in this area. The roof joist split was the cause, with this joist needing replaced, or a sister-joist added along side. When these types of cosmetic items are noted, further inspection is needed, to verify the cause.
