Scott Home Inspection, LLC

Inspection Picture of the Month:

Settlement, settlement, everywhere... With the strange winter weather we have had this last couple of months, signs of settlement and heaving are evident everywhere. While potholes are all over the news, it is time to take a close look at driveway and walkway damages.

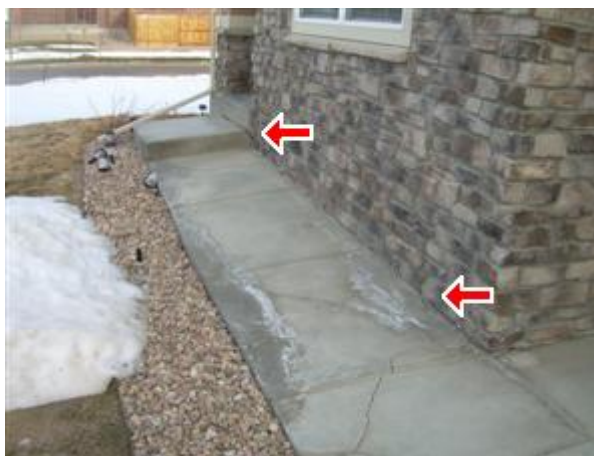
This home showed signs of extensive settlement of the front walk.

The front step had dropped dramatically, pulling away from the porch and showing extensive cracking. The most likely cause of this type of issue is poor compacting and fill of the soil below the walkway, prior to pouring of the concrete. After a few winter's, extensive soil settlement can occur.

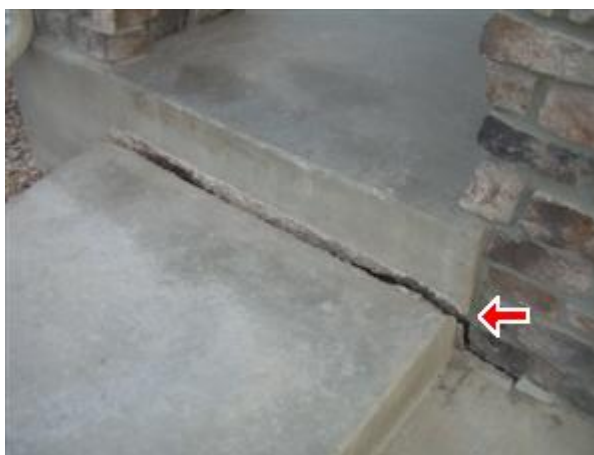
While some cracking is to be expected in our climate, this amount of settlement and cracking of the concrete is excessive. While mud-jacking may be possible, it is likely a full replacement of this walk will be needed.
