MARCH, 2008

Scott Home Inspection, LLC

Inspection Picture of the Month:

Knob-and-Tube Wiring: Very rarely do we run into this old style of electrical wiring, but on occasion, in a very old home, you can find knob-and-tube wiring still in use.

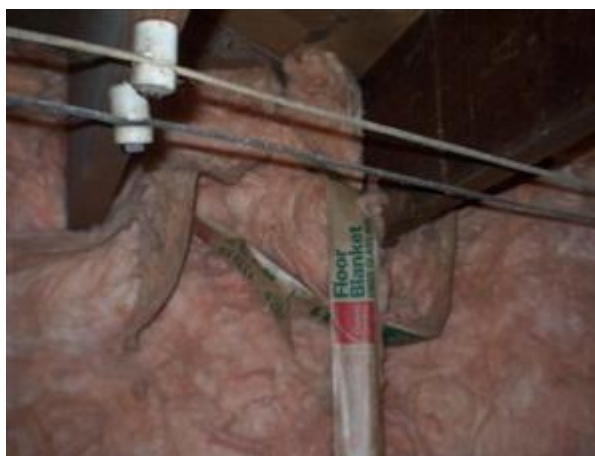
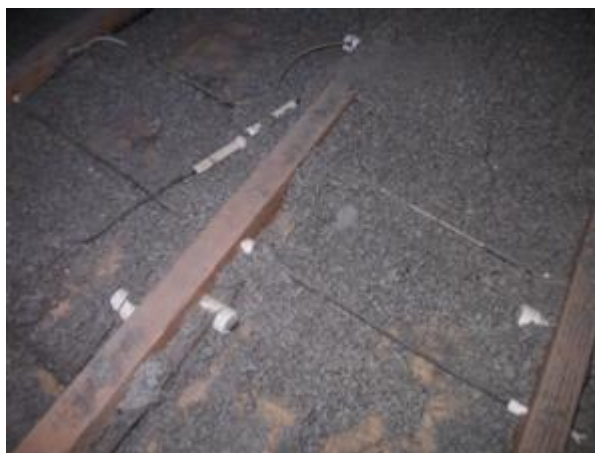
This wiring was used widely as the method for wiring a home. The hot and neutral wires are run as two separate wires, mounted on insulated posts (knobs), and run through insulated sleeves (tubes). This type of wiring was un-safe, as exposed connections could be contacted, causing possible electric shock to occur.

If this wiring is discovered in a home, usually in an attic or crawlspace, it will be recommended that this wiring be removed and upgraded by an electrician. This can be a considerable expense, but one that is necessary to prevent fires and prevent electric shock hazard.
