Scott Home Inspection, LLC

Inspection Picture of the Month:

Octopus Furnace: Very rarely do we run into this old style of gravity based furnace, but in some older homes they are still present.

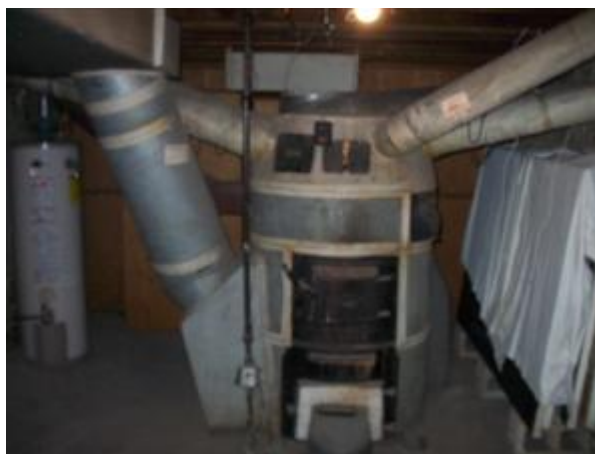
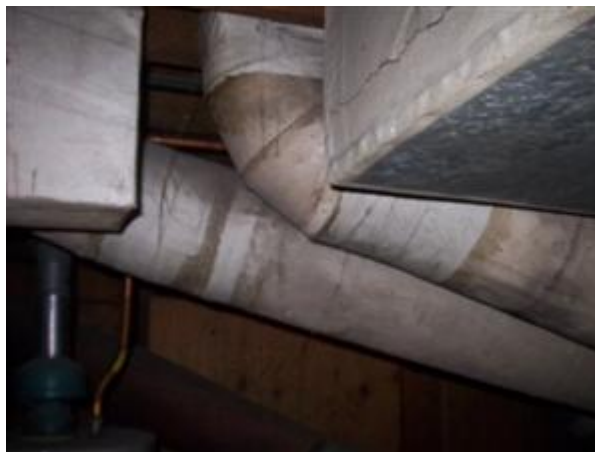
These heat systems relied on gravity to move heat through the home, and originally burned coal. The coal burner assembly is converted to a gas burner. Usually the ducts are wrapped with an "asbestos-like" material.

Replacement costs for removal of these older units, abatement of asbestos, installation of a new furnace and new ducts can run anywhere from \$10-20k. If you run into this type of heating in a home, be prepared for high replacement costs.
